FEMA Higher and Drier In Wisconsin

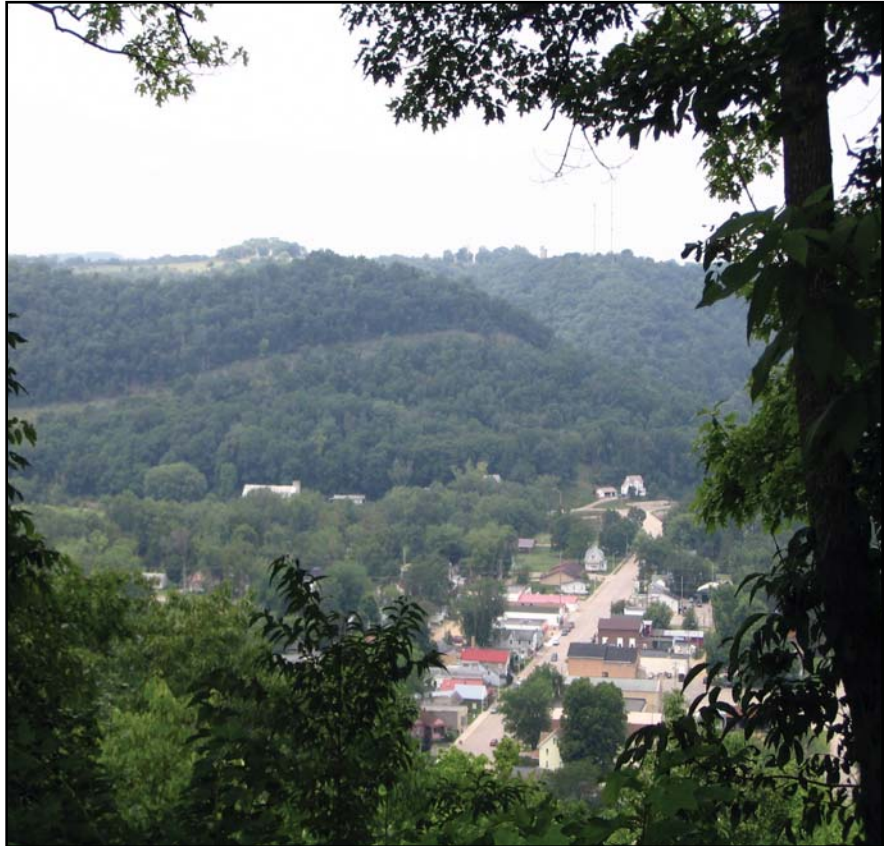
Gays Mills after the 2008 floods. The Kickapoo River flows through this relatively narrow valley with a long history of flooding.

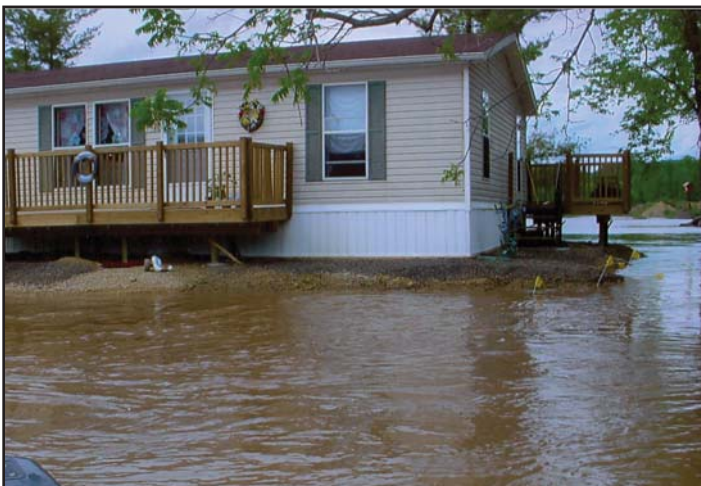
Flood waters in June 2008 rose to about three feet below the Evans' newly elevated home.

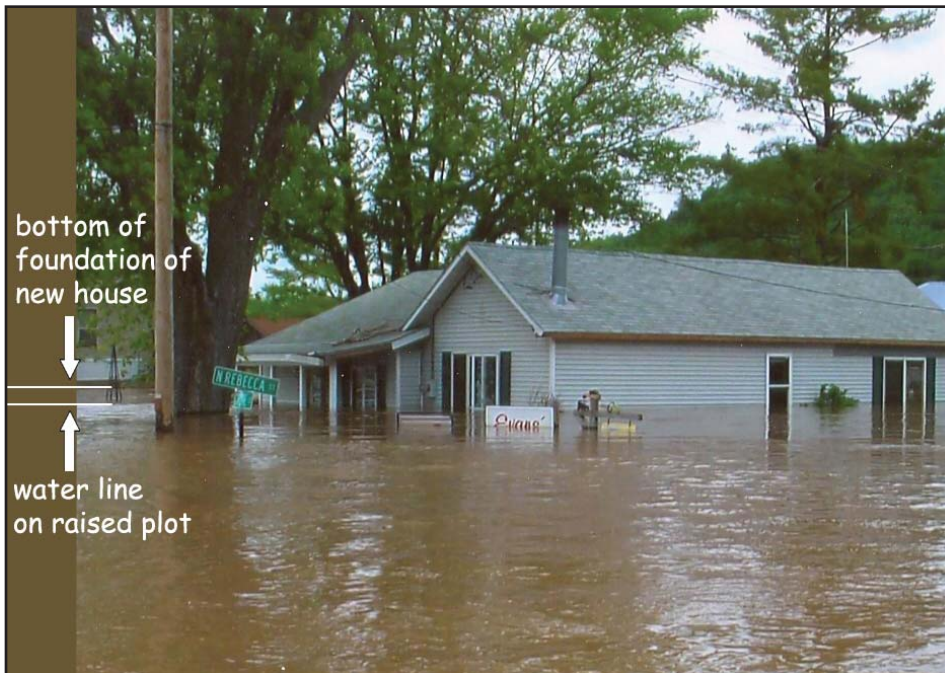
During the 2007 flood the Evans' lived in this house. Their new home is in the background at the left of the photo, protected from damage because of mitigation measures.

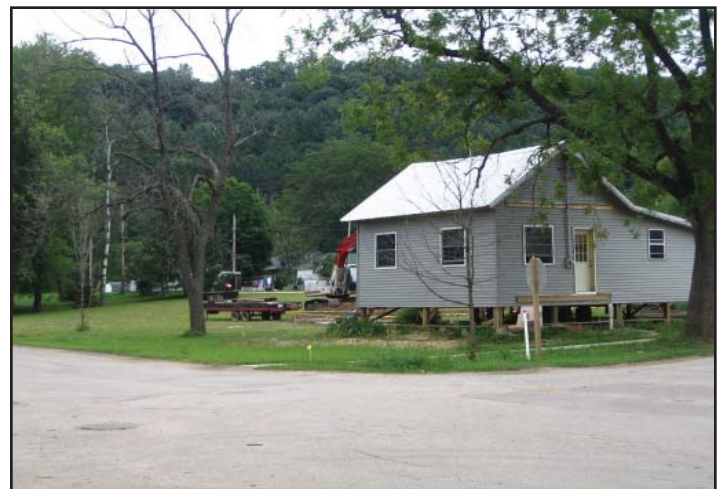
Diagonally across the street from the Evans home, a neighbor is preparing to build a new, elevated foundation next to his house to lift it above the Base Flood Elevation. It was already raised on 4x4 timbers, ready for moving, when the June storm of 2008 arrived, thus avoiding flood damage.

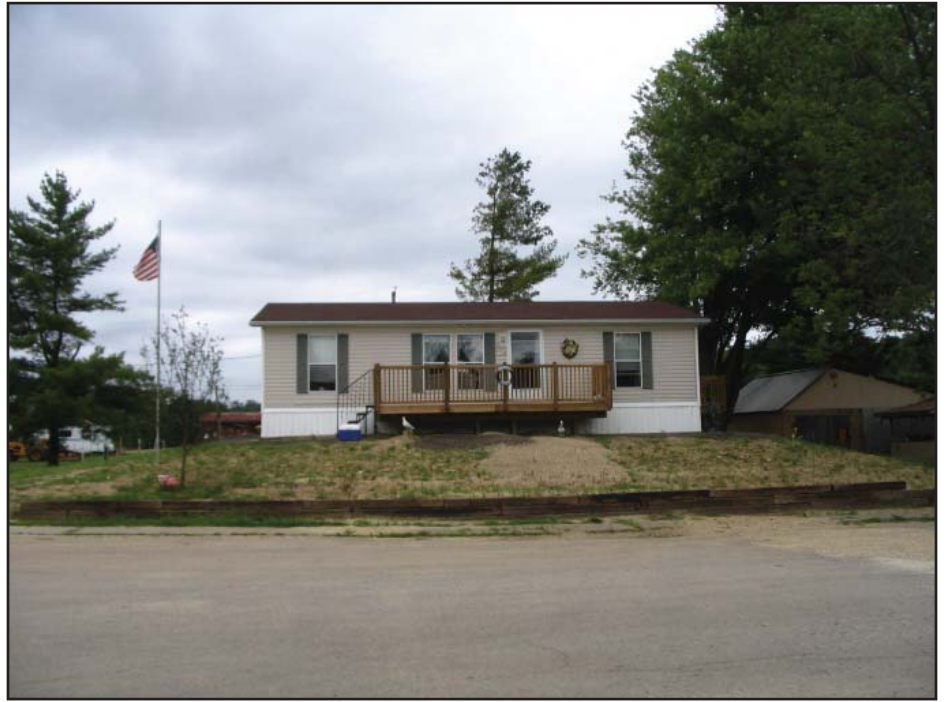
Elevated on approximately six feet of compacted fill, the Evans' home stands dry and undamaged after being tested in the summer 2008 floods.

decided to elevate this large piece of land to three feet above the Base Flood Elevation (BFE). The BFE is the minimum standard that many communities use to regulate floodplain development under the National Flood Insurance Program (NFIP). In his case, if he could raise the level of his house plot to above the BFE, he would only have a one-percent chance of flood waters reaching his new home on this raised plot.

After receiving local approval, a total of 38 tandem truck-loads of fill were off-loaded, and each one was tamped down tightly on the new lot. A manufactured home was offloaded from a large flatbed truck and a crane was used to lower it onto the footings of the newly raised lot. Town water and sewage lines were hooked up and the electrical lines were re-connected. Now he was back in business and secure in a new home.
